Location: Lohja, Finland

case study: 04-2021

VS3A60 PMB

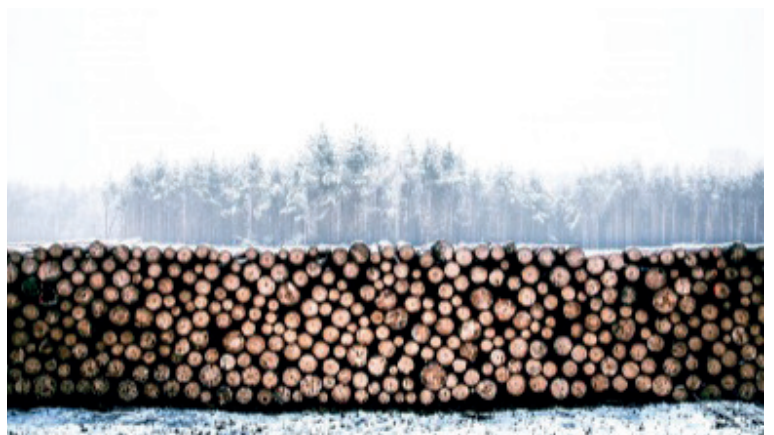
Tree trunks must be kept wet for a period between 9 months and 3 years to prevent the trunks from warping.

These tree trunks must be kept wet for a period between 9 months and 3 years, to prevent the trunks from warping. Also, keeping the trunks wet is better for the durability of the final product and it is easier to peel off the bark.

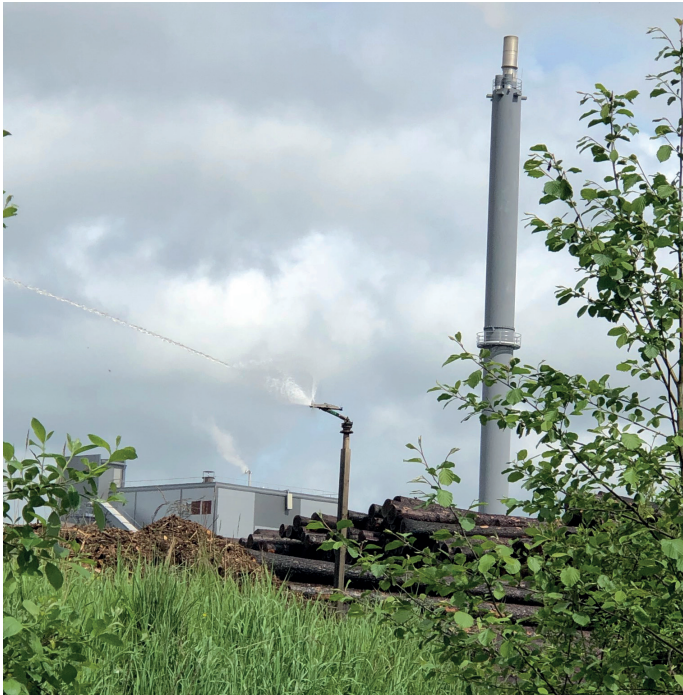
This picture shows the spray beam, keeping the tree trunks wet and being pressure fed by the Gorman-Rupp pump.

On this industrial plant, submersible pumps were used to pump the water from a collecting sump to the site where the trunks are stored. On site, the spray water is collected in the sump, in fact forming a closed recirculation system. When the tree trunks are wet, loose parts of the bark are sprayed off in the process, which flow back into the sump where the submersible pumps were installed. These pumps cannot handle the continuous flow with chunks and blocks, causing frequent blockage and rapid wear on the submersible pumps.

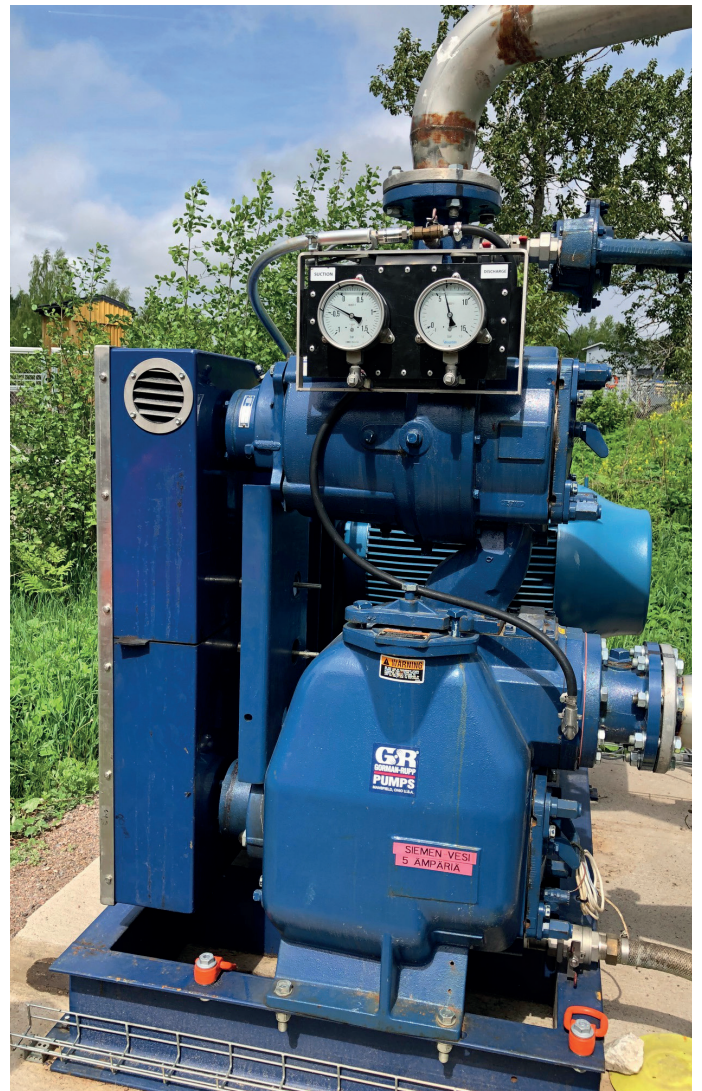
Gorman Rupp VS3A60 self priming centrifugal pump

A Gorman Rupp VS3A60 self priming centrifugal pump has been installed. This pump operates 24 hours /day and has been in operation since 2017 without any problem. Thanks to the robust construction and the large solids handling capacity of the Gorman-Rupp pumps, clogging is now a thing of the past. Once per year (in spring time) the local Gorman-Rupp representative performs the maintenance on the pump. This involves an oil change, adjusting clearances and an overall inspection.
